## **03/18/89 Evergreen International Airlines**

## Official Accident Report Index Page

Report Number	NTSB/AAR-90/02
Access Number	PB90-910402
Report Title	Evergreen International Airlines, McDonnell Douglas DC-9-33F, N931F, Saginaw, Texas, March 18, 1989
Report Date	April 23, 1990
Organization Name	National Transportation Safety Board Office of Aviation Safety Washington, D.C. 20594
WUN	5094A
Sponsor Name	NATIONAL TRANSPORTATION SAFETY BOARD Washington, D.C. 20594
Report Type	Aircraft Accident Report March 18, 1989
Distribution Status	This document is available to the public through the National Technical Information Service, Springfield, Virginia 22161
Report Class	UNCLASSIFIED
Pg Class	UNCLASSIFIED
Pages	85
Abstract	This report explains the crash of an Evergreen International Airlines McDonnell Douglas DC-09-33F, N931F, in Saginaw, Texas, on March 18, 1989. The safety issues discussed in the report include the cargo door closing procedures on DC-9 airplanes; the external cargo door markings on DC-9 airplanes; the door warning switch electrical wiring on DC-9 airplanes; and the actions of the carrier and the Federal Aviation Administration concerning these issues preceding the

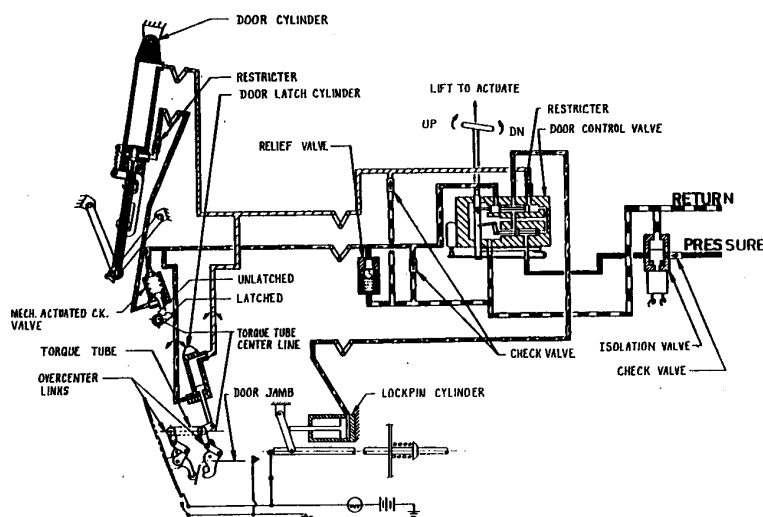
Figure 1.--Hydraulic routing within the cargo door hydraulic system.

1. The cargo door control valve - This valve was found in the "valve neutral" position (as opposed to the "door open" or the "door closed" position) within the wreckage. Damage to the valve did not allow testing in the "door open" or "door closed" positions. The valve was disassembled at its manufacturer's facility and no anomalies were found. [See Figure 1](#) for a cut-away diagram of this valve in its three operating positions.

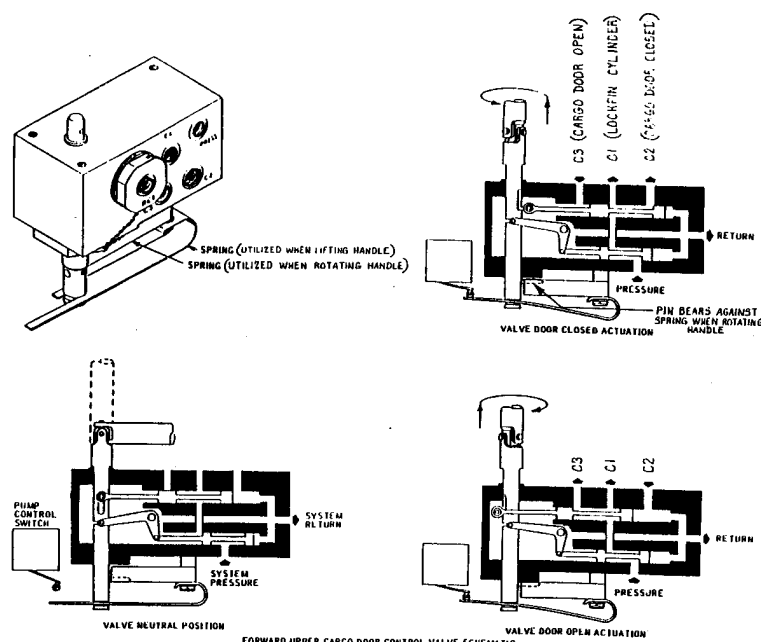
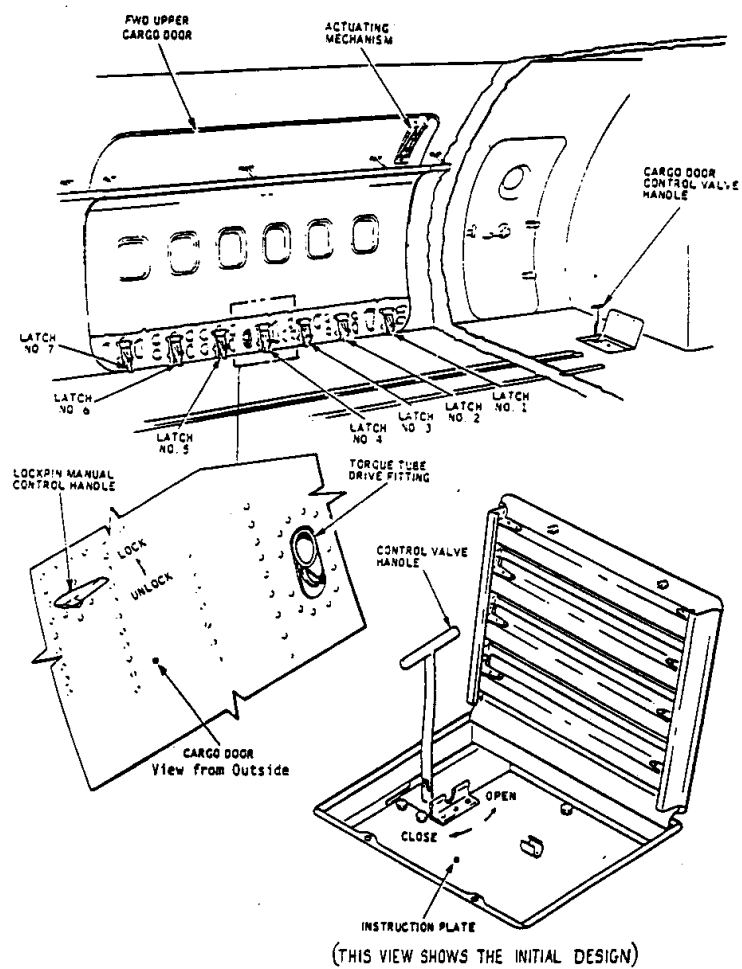
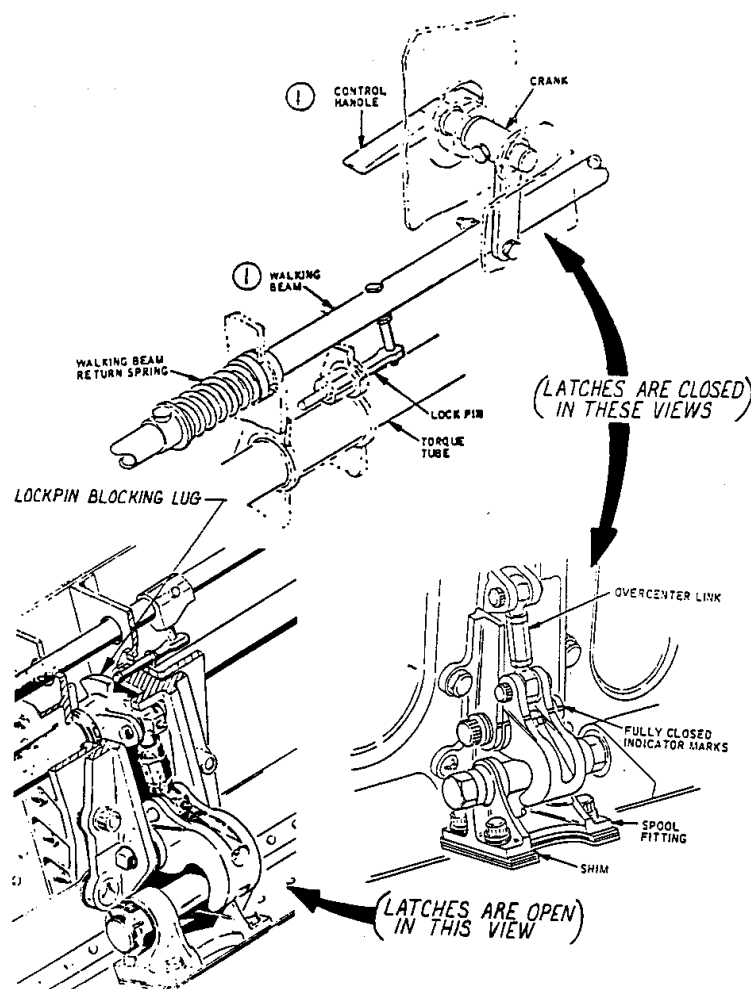
Figure 2.--Main cargo door components.

The seven hook-shaped door latch assemblies along the lower edge of the door on the latch assembly torque tube were intact and none of the latch assembly surfaces showed excessive wear or deformed areas. All seven were found in the unlatched position on the torque tube. The forward (No. 1) latch assembly was displaced aft about 18 inches. The No. 2 latch assembly was displaced aft about 7 inches.

The lockpin walking beam was intact and in place within the door and appeared to have received very little, if any, axial aft impact movement. The aft lockpin spring was found attached to the walking beam. This walking beam and the latch assembly torque tube were not free to move because of impact damage to the corner of the door. The lockpin actuating cylinder was found extended 1/2 inch from the support assembly.

The latch assembly torque tube cam that operates the hydraulic sequence valve was found rotated to the full open position. The sequence valve was intact and attached to the door. The valve plunger could be manually operated by hand. The lockpin cylinder actuating lever at the forward end of the door was broken from its attaching structure.

The external cargo door latch assembly torque tube drive fitting was in the unlocked position. The external lockpin manual control handle was in the door unlock position also. There was about 1/8 inch of play in the handle as it was found in the wreckage.

Six of the seven lockpins were found in the door in the unlocked position (i.e. not inserted in the latch assemblies). The No. 4 lockpin was not recovered in the wreckage.

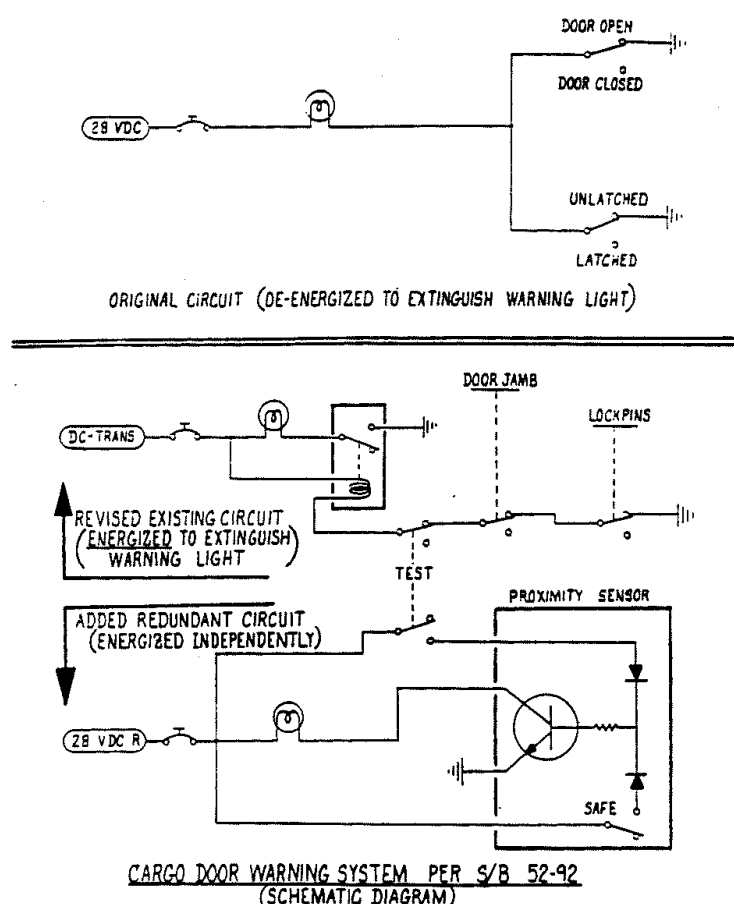
Figure 3.--Cargo door warning switch electrical diagrams.

The SB modification eliminates an undesirable failure mode of the original cargo door cockpit warning light system wherein a failure of either the door jamb switch or the lockpin switch to close will remain undetected and the cockpit warning light will appear to function normally; that is, the light would illuminate when the other functional switch closes and extinguish when it opens. Thus, if the lockpin switch is the one failed, the door will appear safe when closed even though it is not fully latched and locked. The modification to the existing circuit consists of adding a relay which must be energized with 28 volts dc to extinguish the cockpit warning light. The door jamb and lockpin switches are rewired in a series circuit so that electrical continuity through both switches will energize the relay. With the logic of the switches inverted and placed in series instead of parallel, a failure of either switch to close will result in an illuminated warning light.

The cargo door latch limit switch/wire/cannon plug assembly was wired into the door warning system in the original configuration without the benefit of SB 52-92 improvements. The original configuration called for this switch and the door jamb limit switch to be connected in parallel to the MAIN CARGO DOOR open warning light on the annunciator panel in the cockpit. [See figure 3.](#) The female connector to this switch was damaged and a small amount of corrosion on the connector was evident. The unit was x-rayed and disassembled. The L-lever of the switch would not fully depress the micro-switch plunger of the assembly and electrical continuity could not be established.

- g. SB 52-92 - Issued on April 7, 1976, with revision 2 on November 21, 1985 - This SB recommended a modification of the original cargo door cockpit warning light system electrical circuit and the addition of a redundant independently energized warning light and circuit.
